SIDECAN SONAR MAPPING OF FREMANTLE SAILING CLUB HARBOUR

Prepared for:
Fremantle Sailing Club

Project: CMST 1077

Report: CMST 2012 v1.0

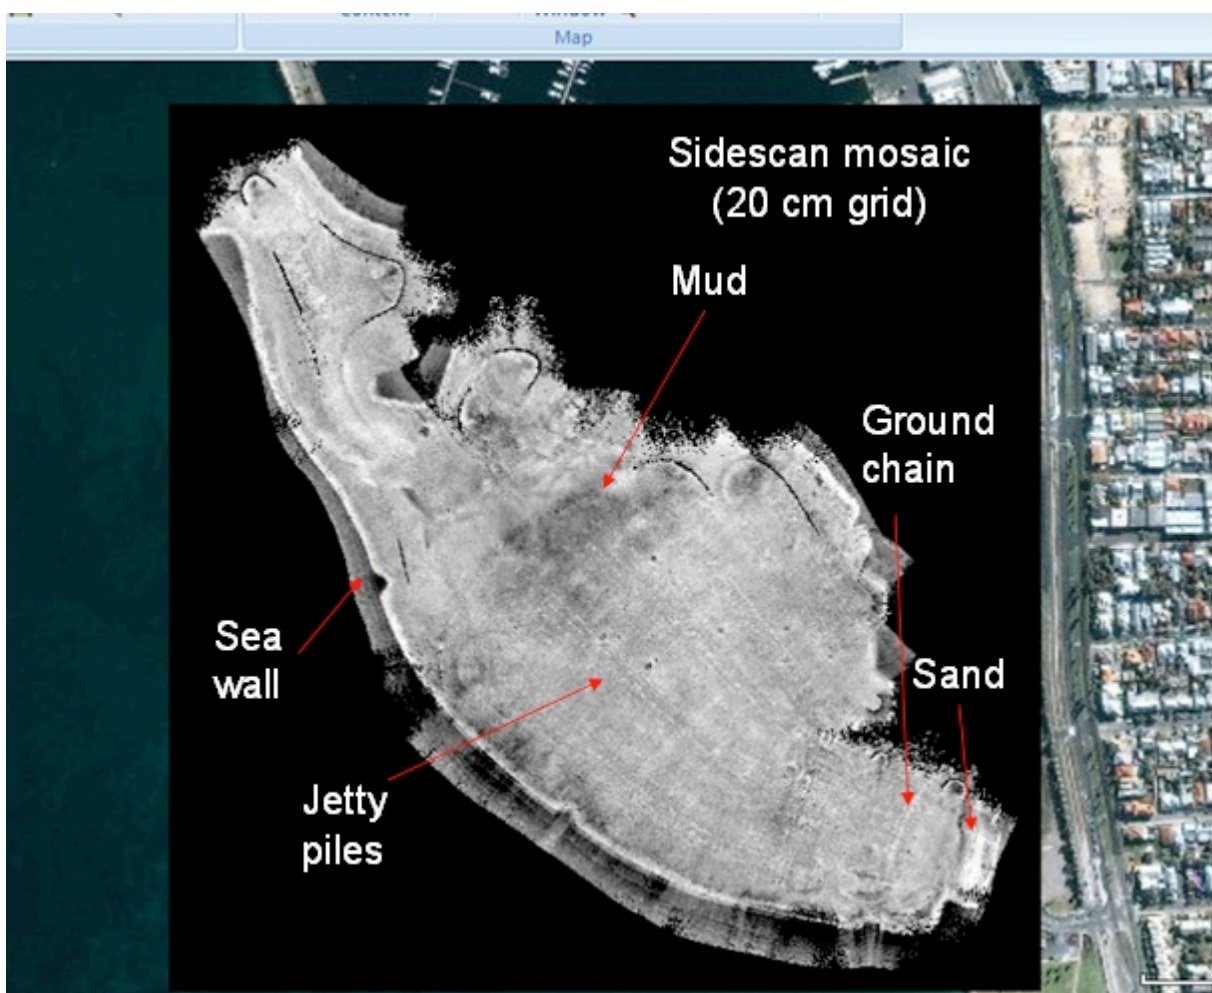
Figure 4 Summary of results

Coverage of the area and large scale features are shown in Figure 4, which is a mosaic of the data. The dark stripes are where there was no coverage. The results show the seabed to consist of mud and sand, with some artificial features such as jetty piles and debris also showing up.

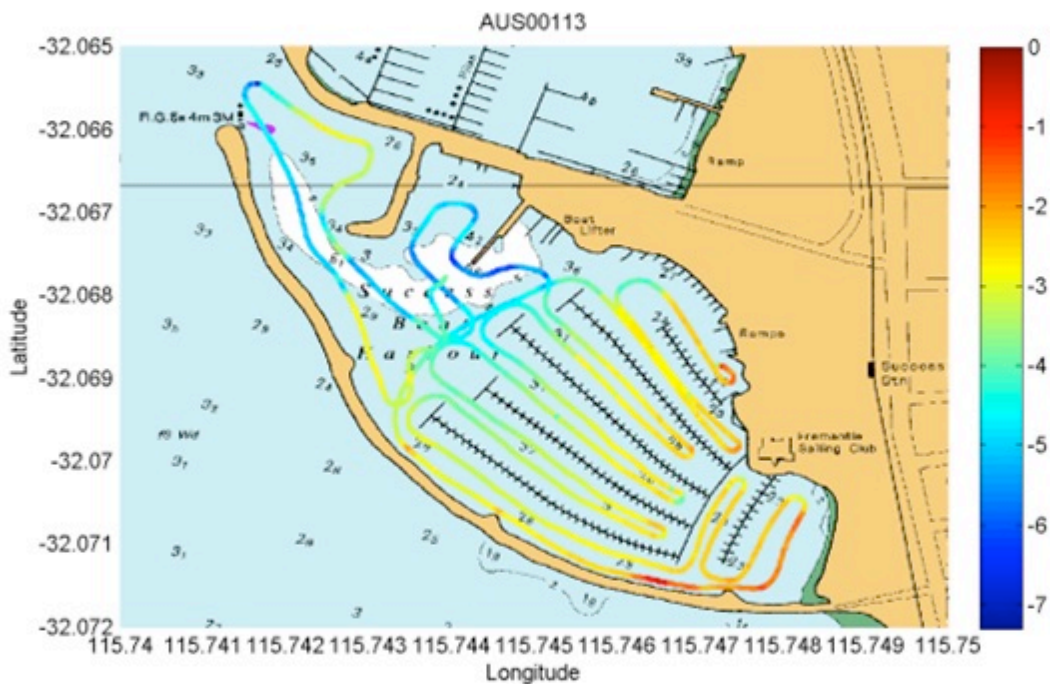
Figure 5 Water depths (m) – uncorrected

The depths in the large pond are 4-5m, around the jetties they are generally 3m and in the dinghy pond they reduce to about 2m. There are some shallow areas near the base of the south-western sea wall where depths are less than 1m. These could be monitored for change by repeating the survey at suitable time intervals.

The full depth data set shows some small but very deep holes in the seabed in several places, the reason for which is not known. The largest of these is on the north-eastern side of C jetty, about half way along. It is 1m deeper than the surrounding area.

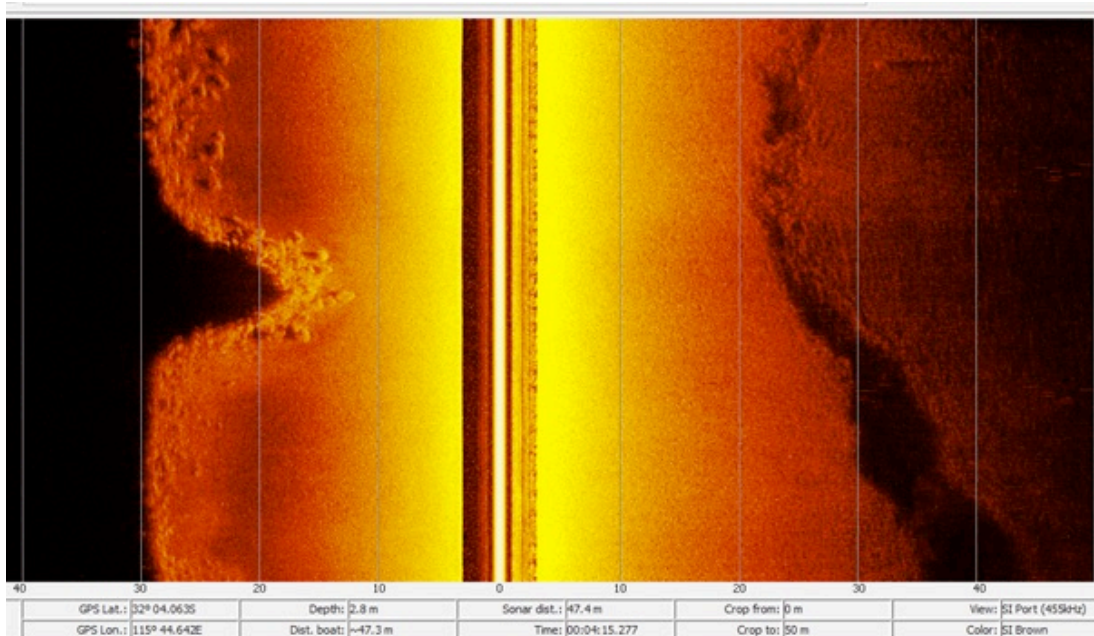
Figure 6 Sea wall

The underwater structure of the groynes and sea walls is clearly shown (Figure 6), with boulders protruding slightly into the channel at some points. Repeating the survey at regular (e.g. annual) intervals could be useful in monitoring degradation of the structure.

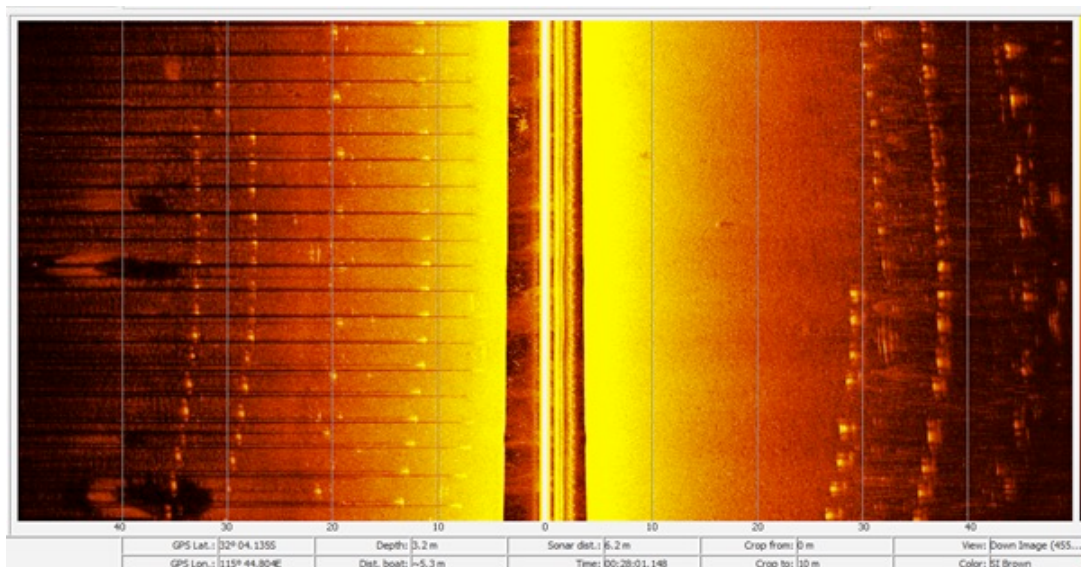
Figure 7 Jetty piles

The jetty piles were visible, as shown in Figure 7. The elongation of their shape and their “wake” is a result of acoustic shadowing. This serves as a reminder that these are acoustic images, which are not the same as a conventional photograph.

In some of the pens there are features which could be the underwater parts of a boat hull. Bear in mind that objects smaller than about 1m across (e.g. a yacht keel end-on) will not show up, nor will objects close to the surface that are above the line of view of the sonar.

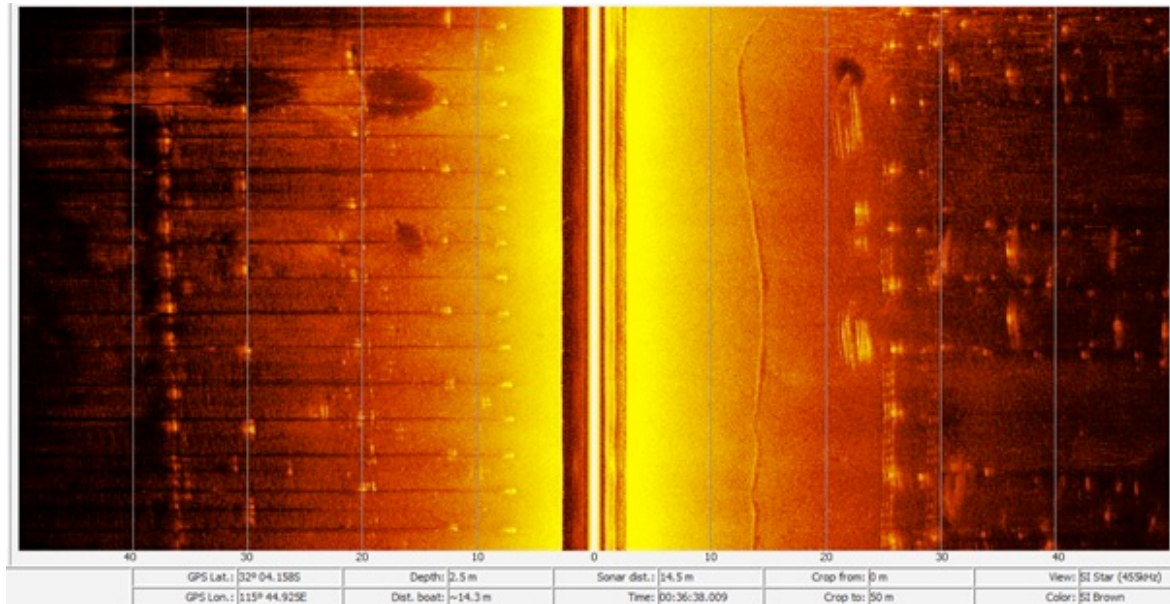
Figure 8 Ground chain at Collector jetty

One feature that is very clear is the ground chain running along the collector jetty (Figure 8). Repeating the survey at regular (e.g. annual) intervals could be useful in monitoring the position and alignment of the chain, though there may be simpler ways of doing this.

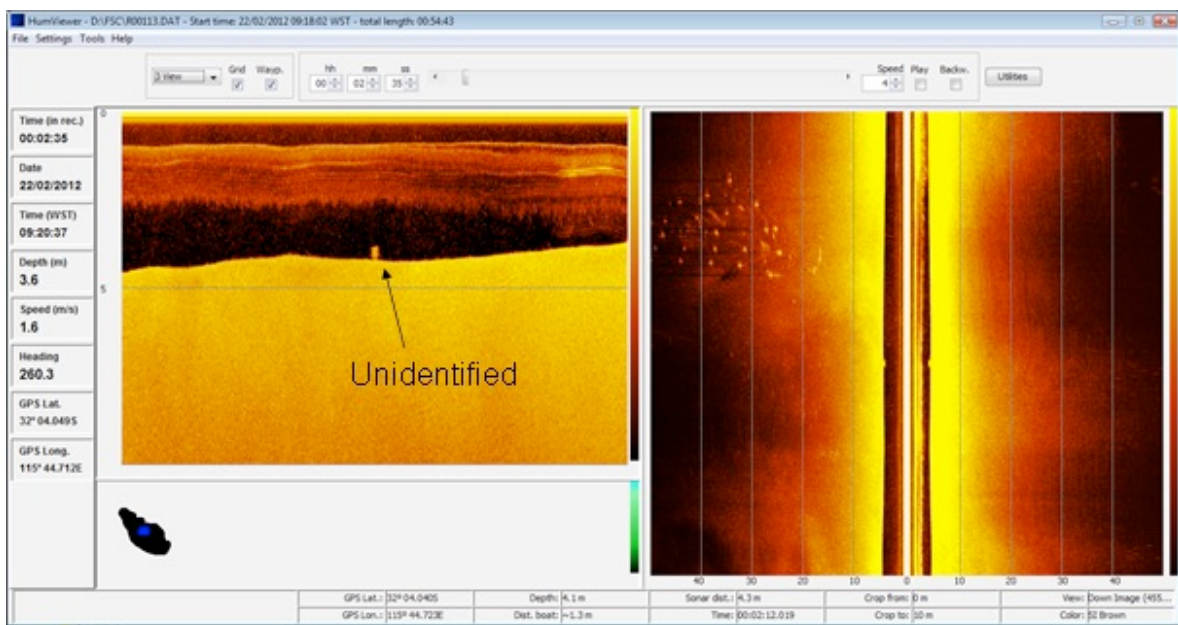
Figure 9 Example of object on sea bed

There are several objects which appear to be debris. Figure 9 shows one such object. The left side of the image is a vertical slice through the water of a short section of the track of the boat (bow to the right), directly under the transducer. It is not possible to see anything directly under the transducer in the plan view (the right hand image in the figure) but there are several objects visible to port, which may extend into the blank zone.

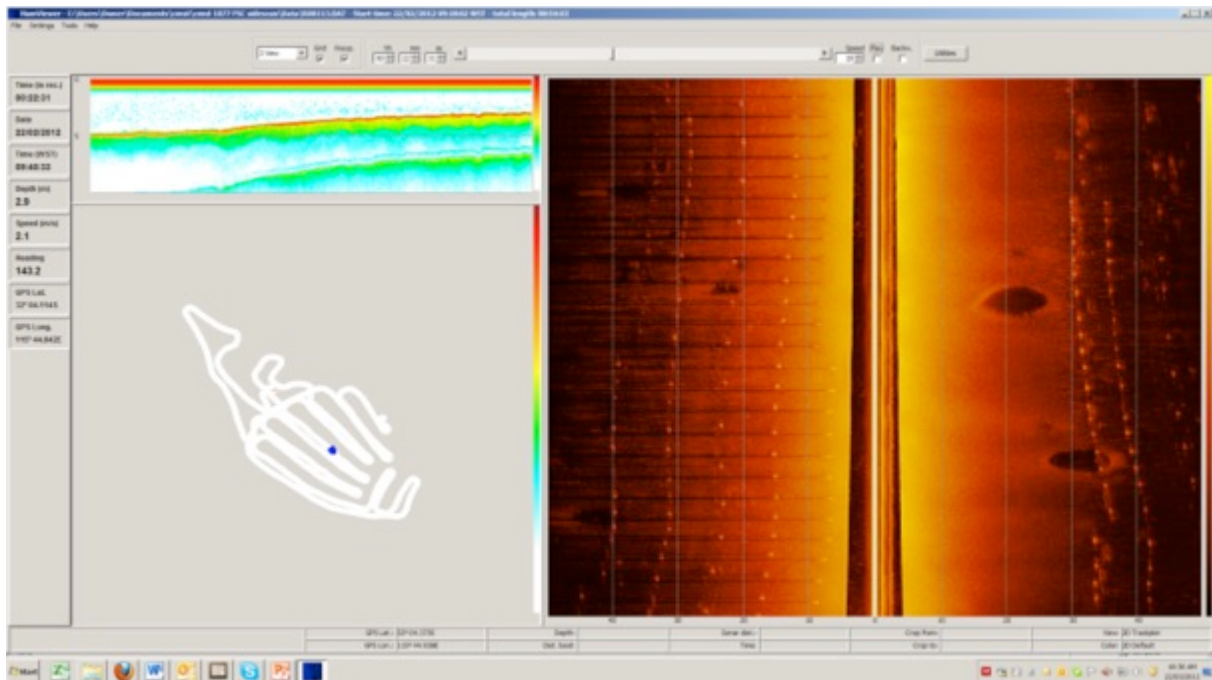
Figure 10 "Black holes" between jetties

One of the more puzzling features is a series of dark, lozenge shapes in and around the jetties e.g. Figure 9. There are about half a dozen of them, particularly around B and C jetties. Sometimes they are accompanied by a large increase in depth (>0.5m)

but this is not always the case. They are probably not all the same type of feature; the sonar will pick up most of them on both the “out” and “return” trip of the vessel i.e. once to port and then again onto starboard. Some of the shapes are replicated on both sweeps, suggested a physical hole in the sea bed or a drastic change in the seabed type. However, others do not show up to nearly the same extent in both sweeps, suggesting the shape is an acoustic shadow formed by a ridge between the transducer and the shape (the ridge would not be in the way on the return sweep, so no shadow would be generated). More detailed analysis of the results or inspection by divers, may improve our understanding of these phenomena.
