Yacht keel design and construction: what can we learn from the capsizing of *Finistere*?

Dr Kim Klaka

RINA WA 28th June 2022

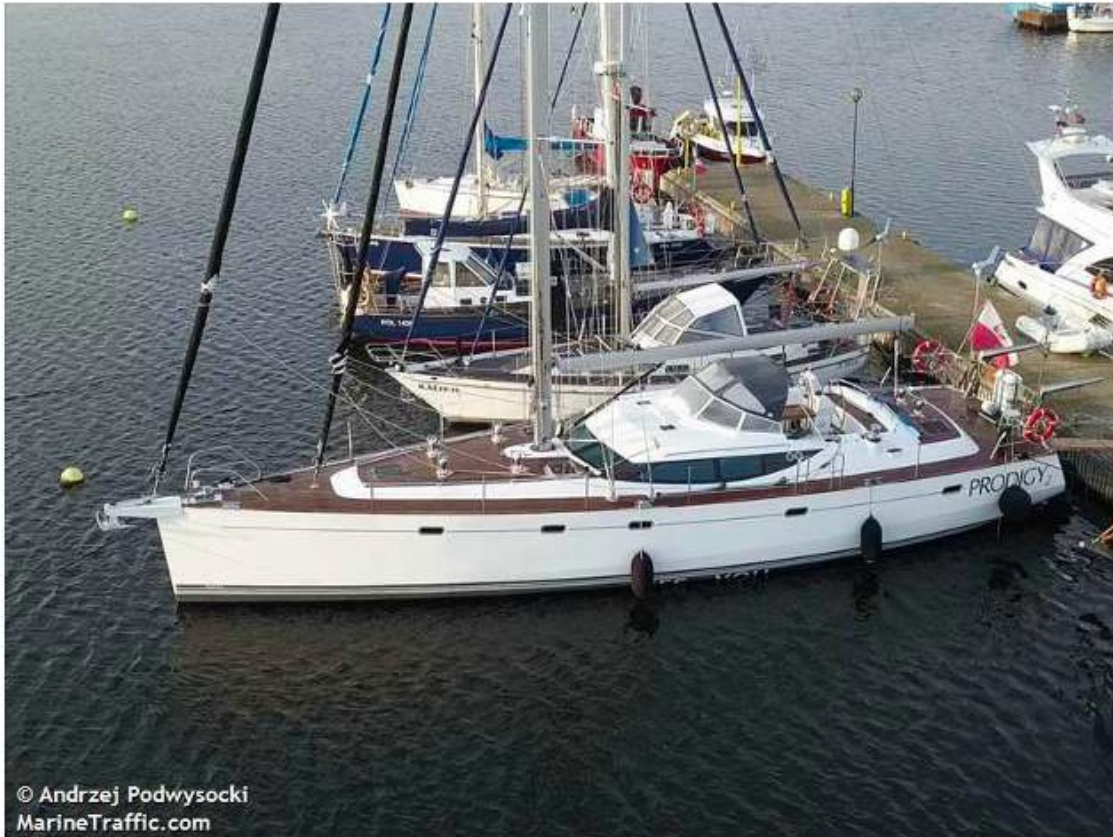
Photograph 1. "Prodigy 2" yacht

Prodigy 2 2017

- Keelbolt washers designed too small
- Low laminate quality

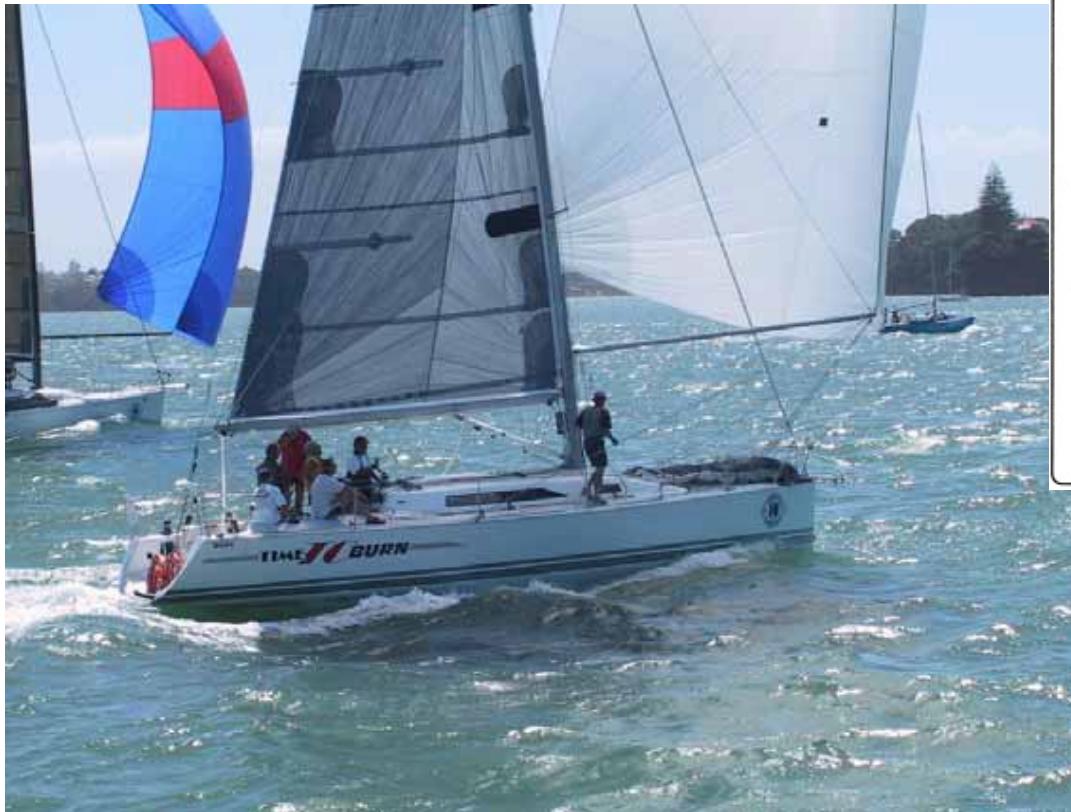
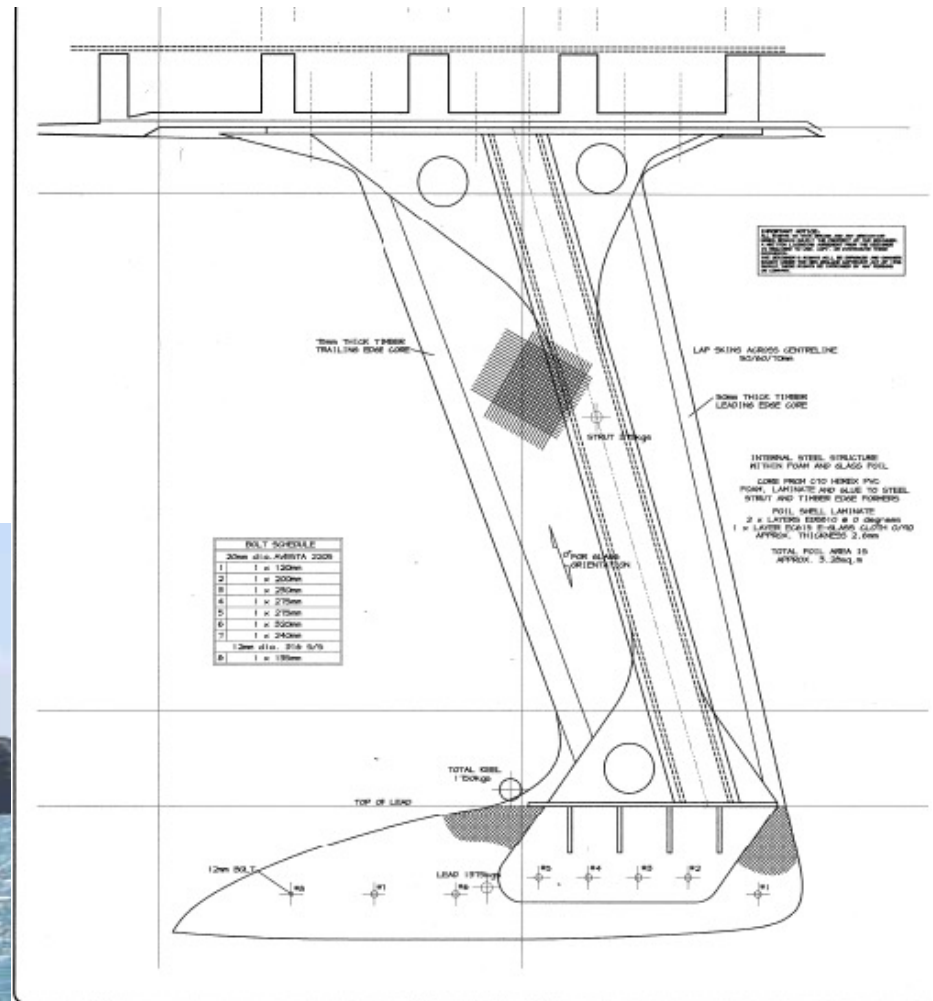
Time to Burn 2008

- Inappropriate design
- Inappropriate welding

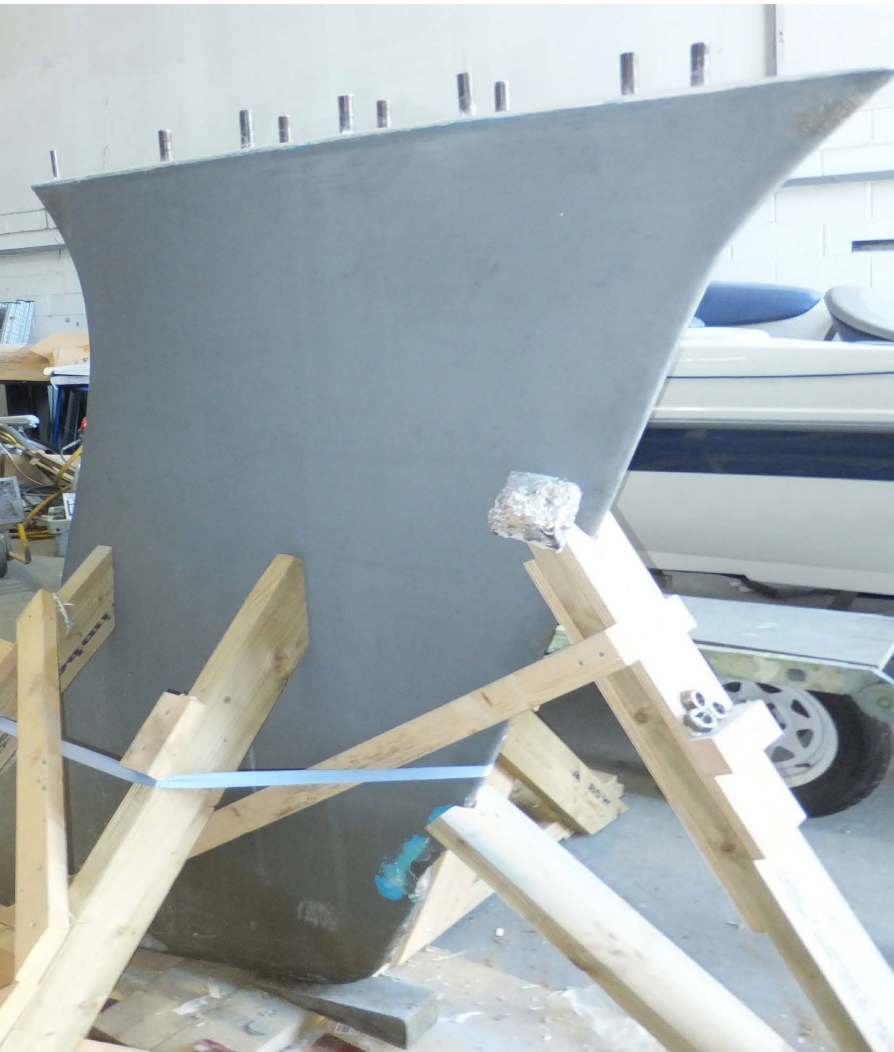
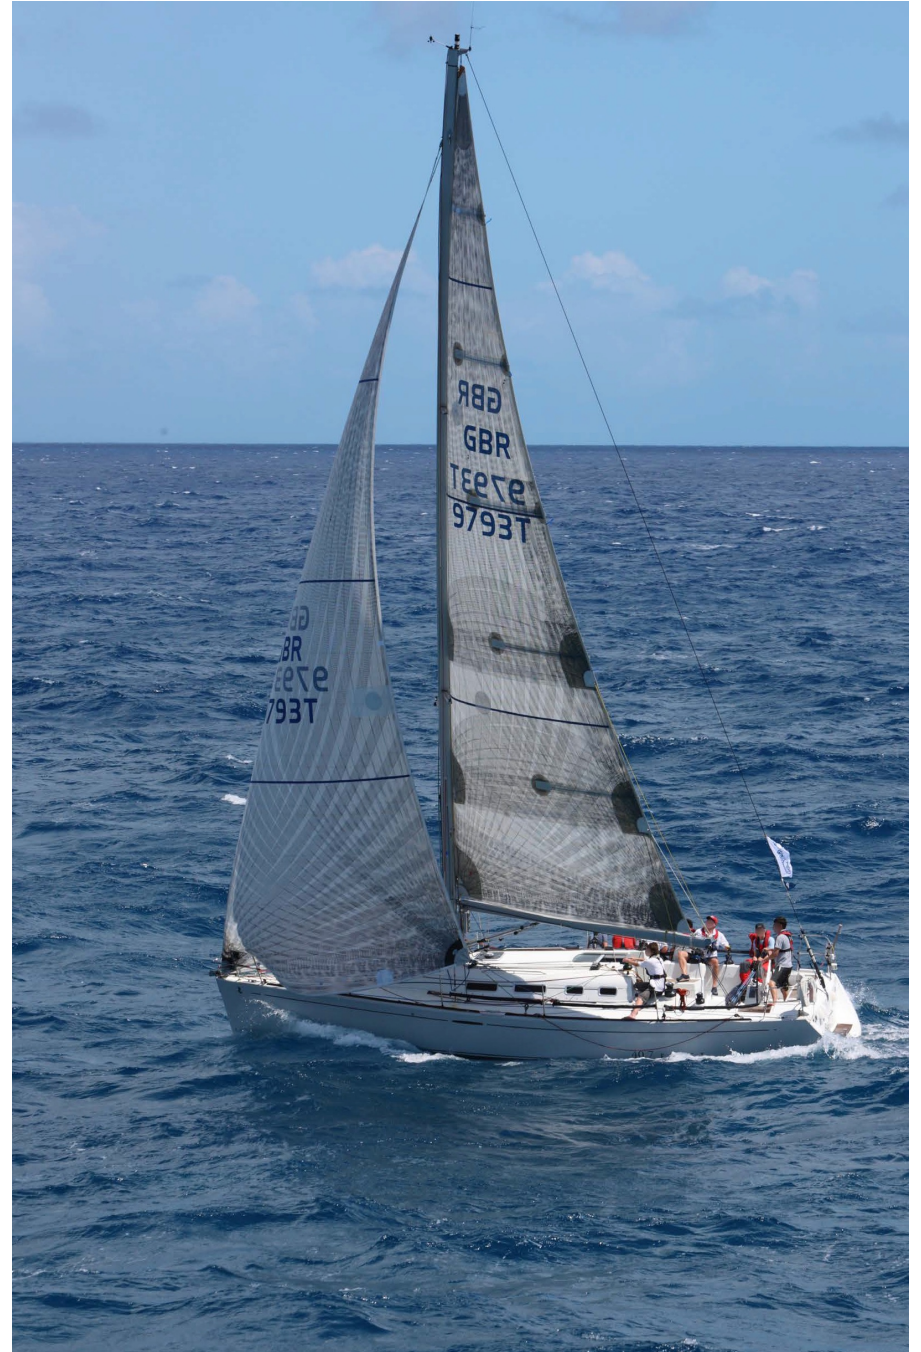
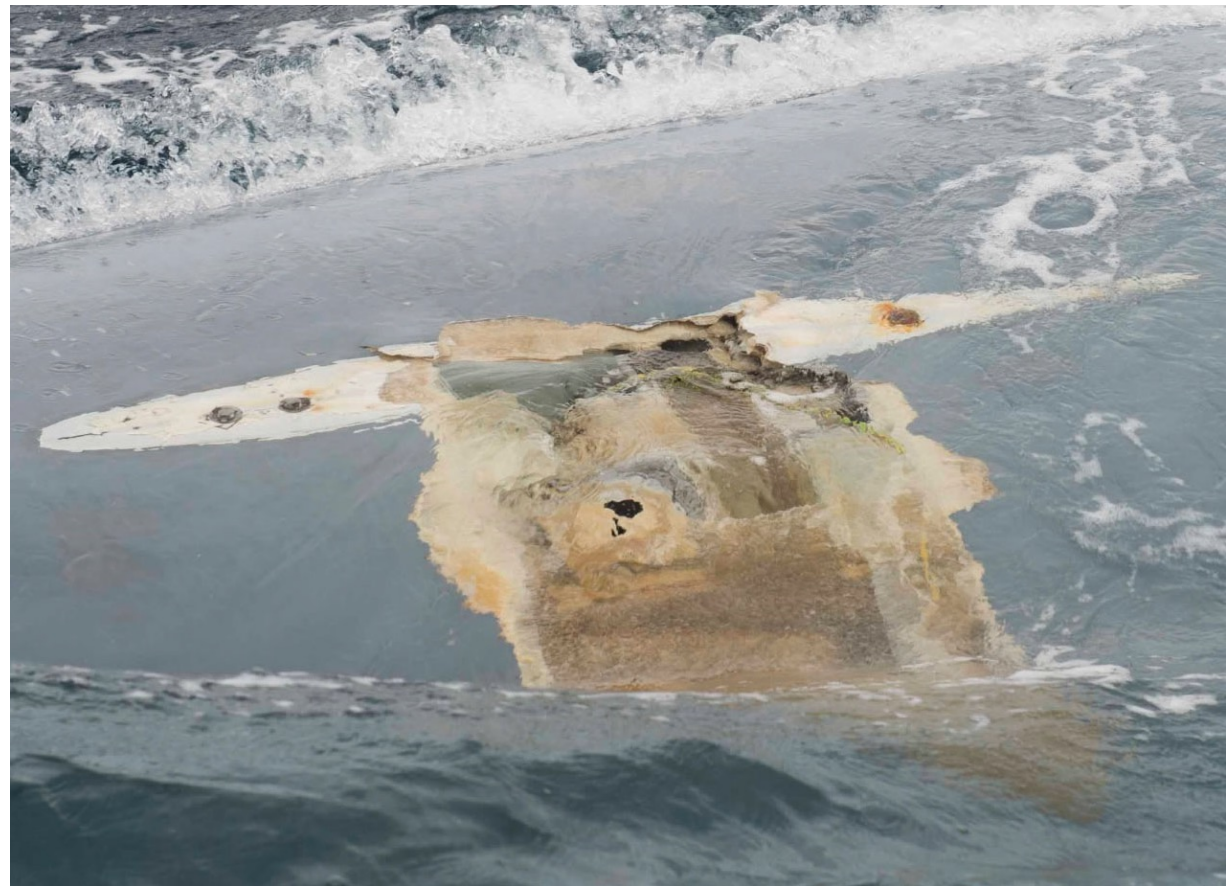
Cheeki Rafiki 2014

“It is possible that some of *Cheeki Rafiki*'s reported 'light' groundings could have significantly affected the integrity of the matrix attachment in way of the keel.
It is also possible that the keel bolts had deteriorated.”

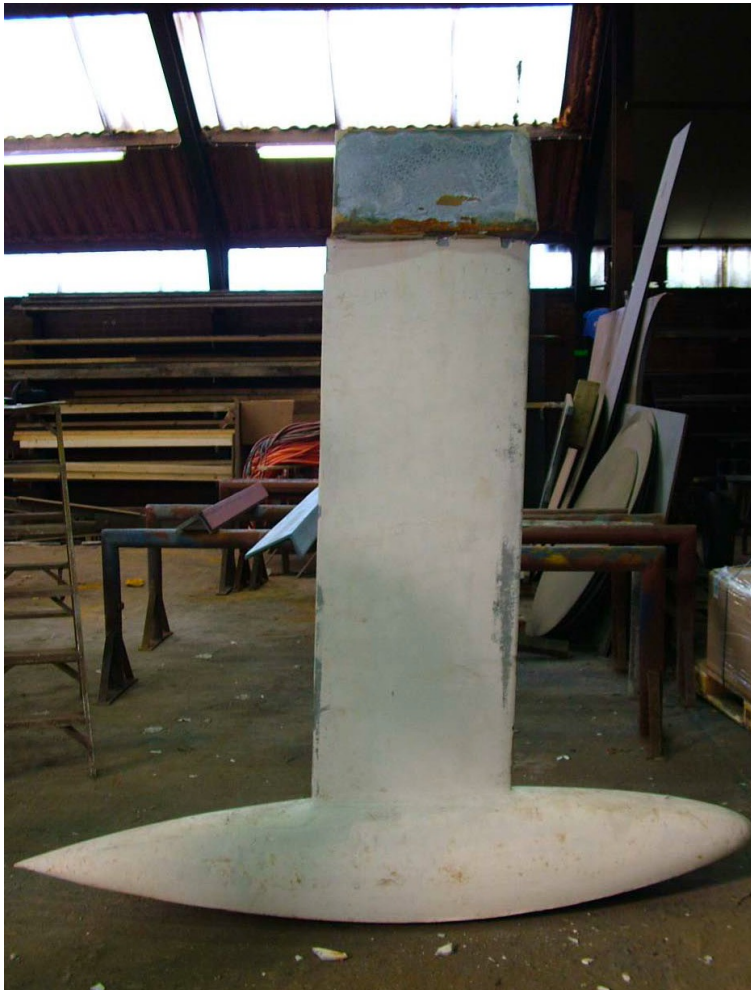
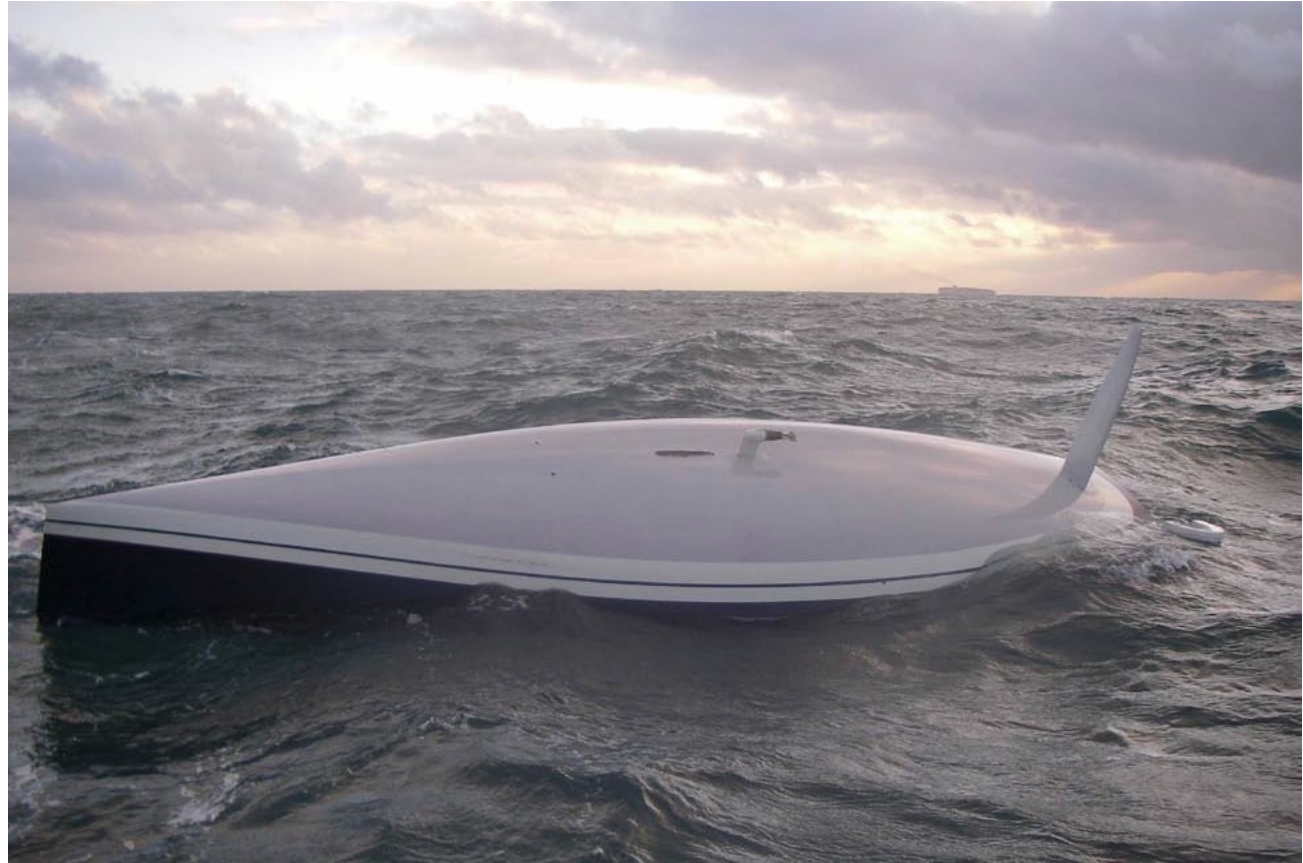
Hooligan V 2007

- Independent analysis of the “original” design calculations confirmed that they did not achieve the required Safety Factor.
- Further analysis of the keel design, as built, showed this failed to achieve the required safety factor by an even larger margin and
- that the subsequent addition of extra bulb weight in 2005 had exacerbated the situation.

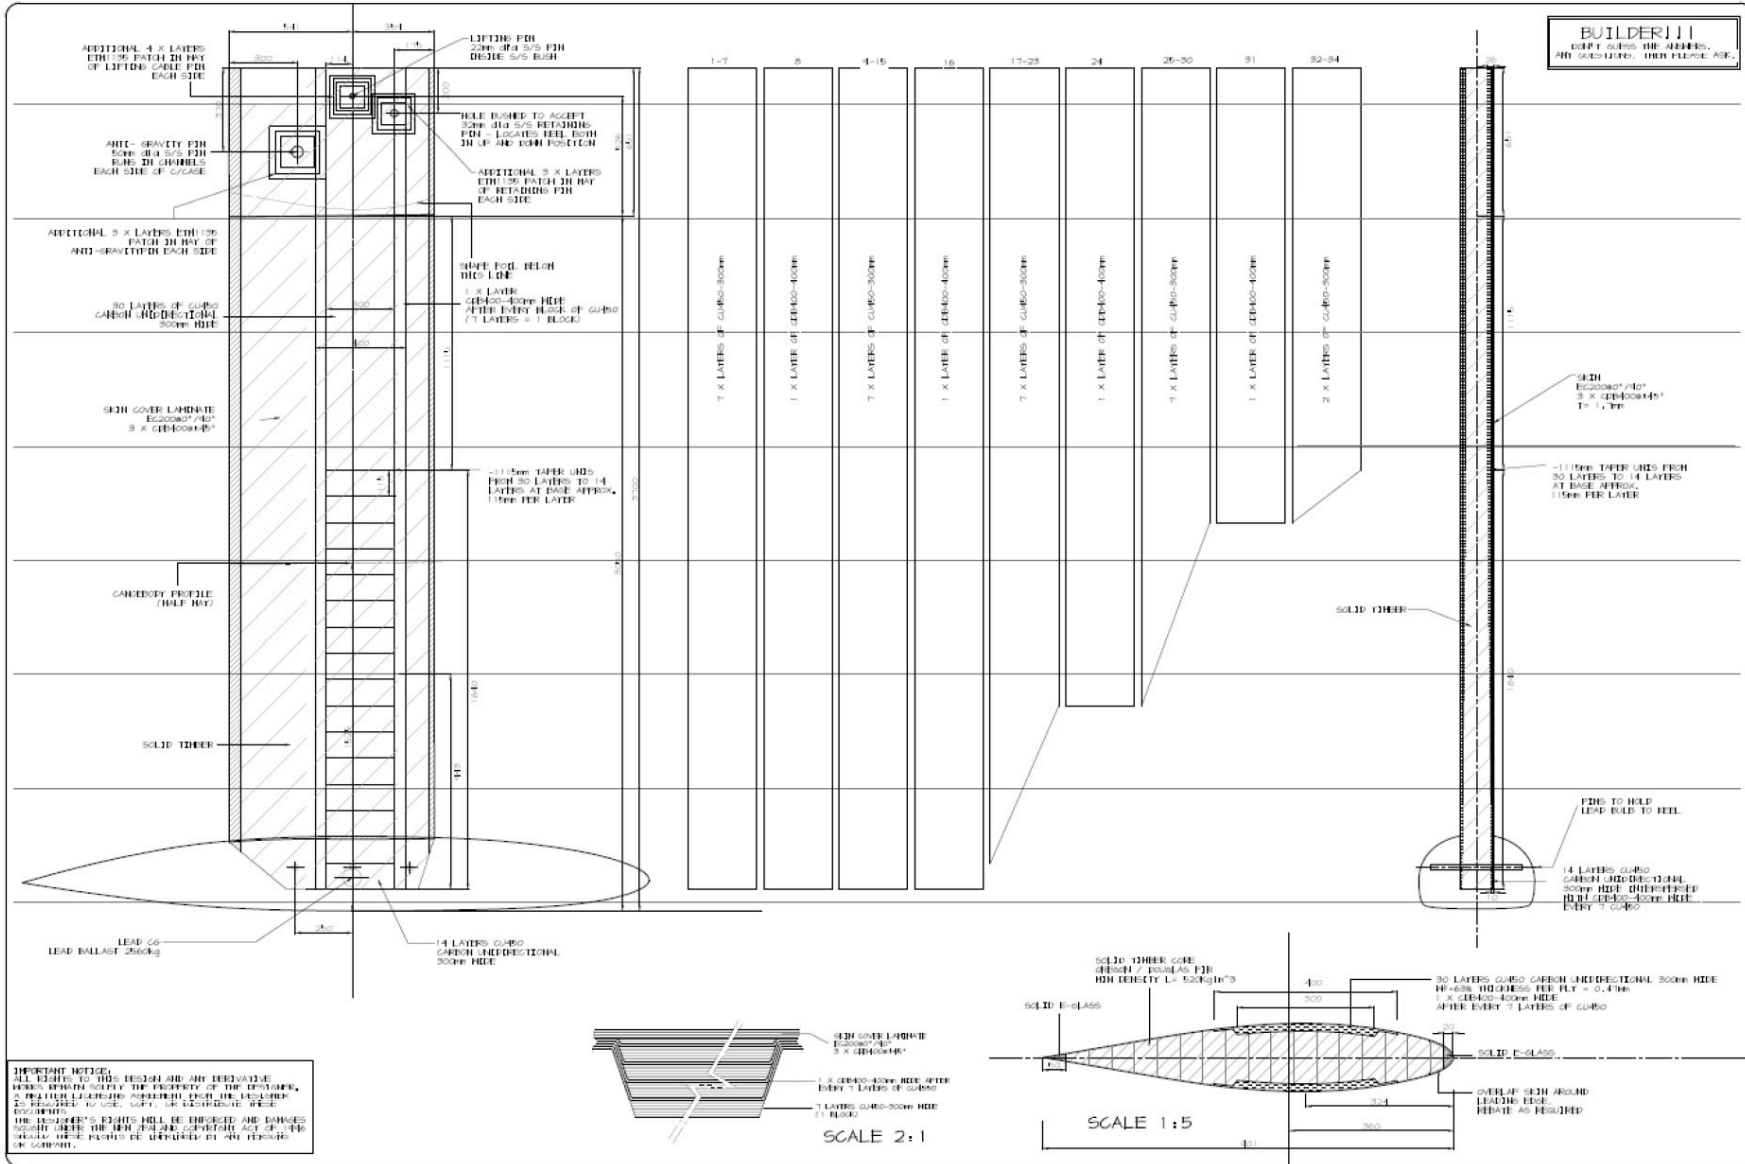
Finistere keel drawing "June 2011"

(June 2011? Compare with dates in previous slide!)

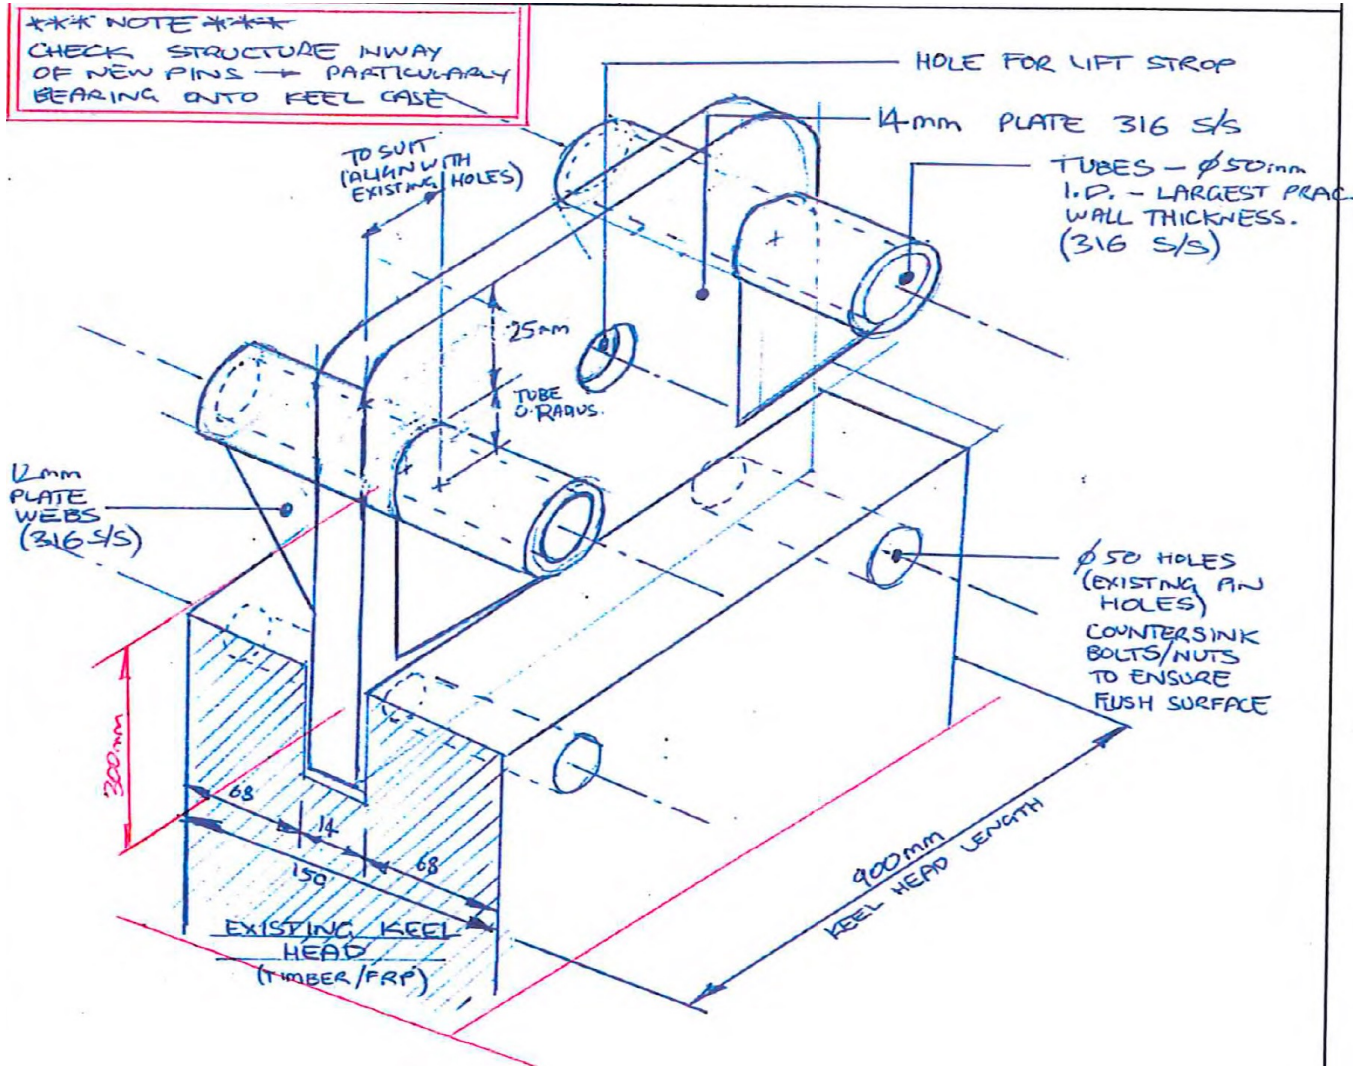
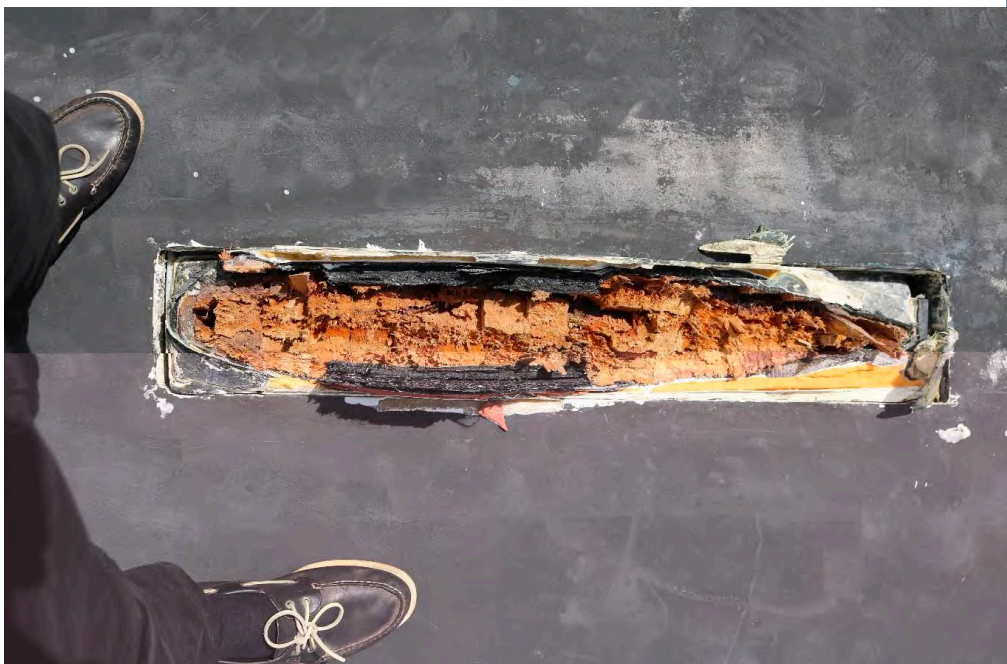
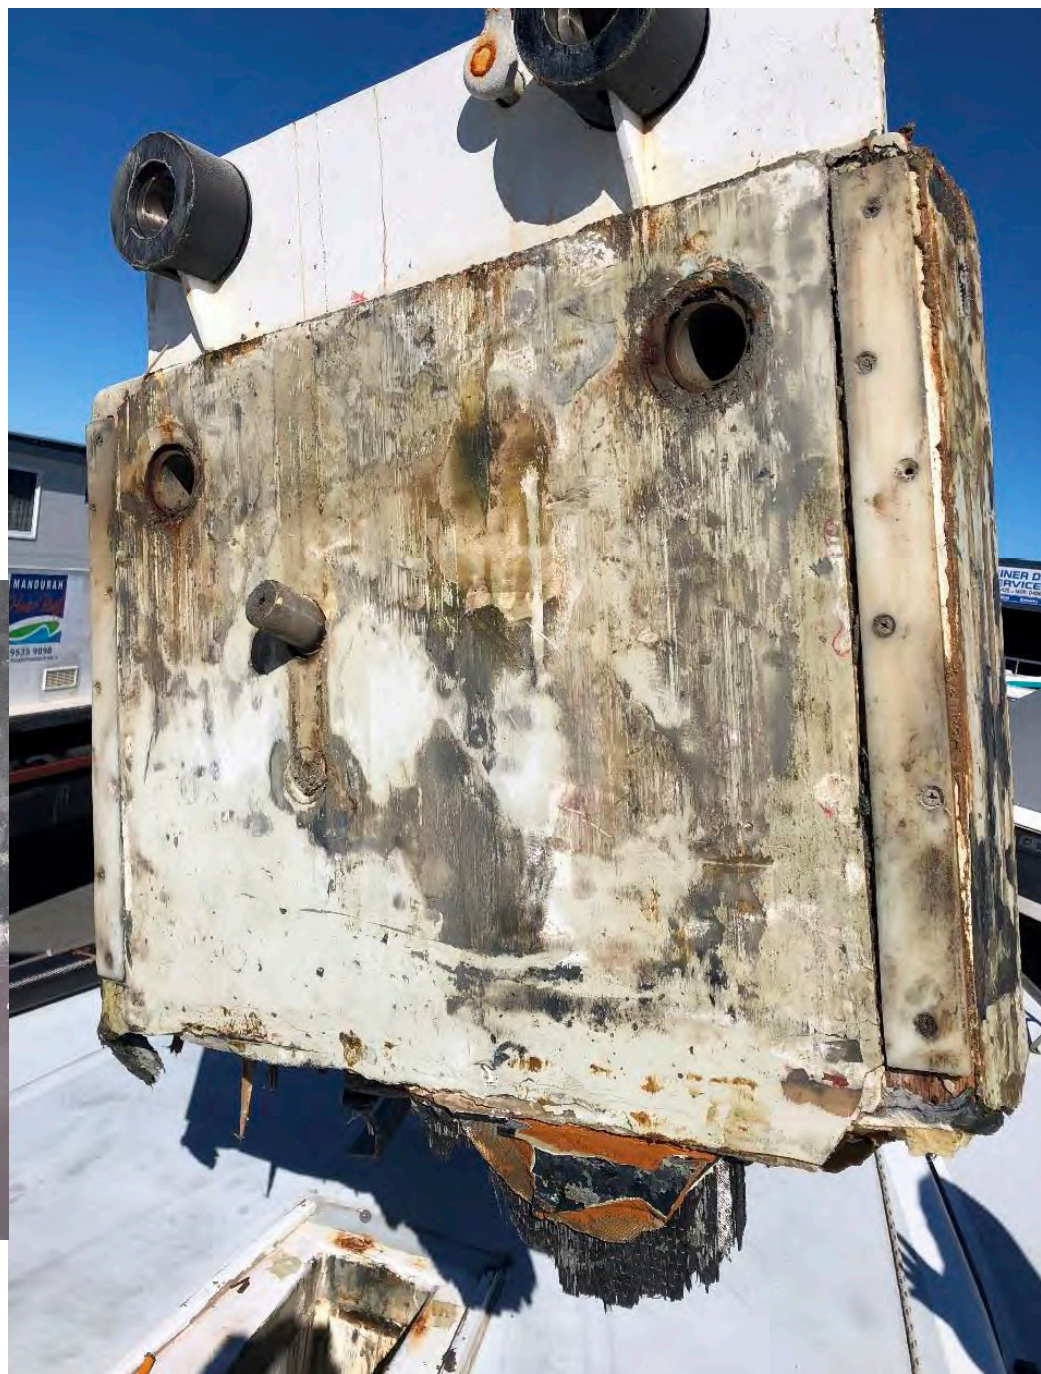
Locating pin mods 2012

POINT OF SHEAR FAILURE

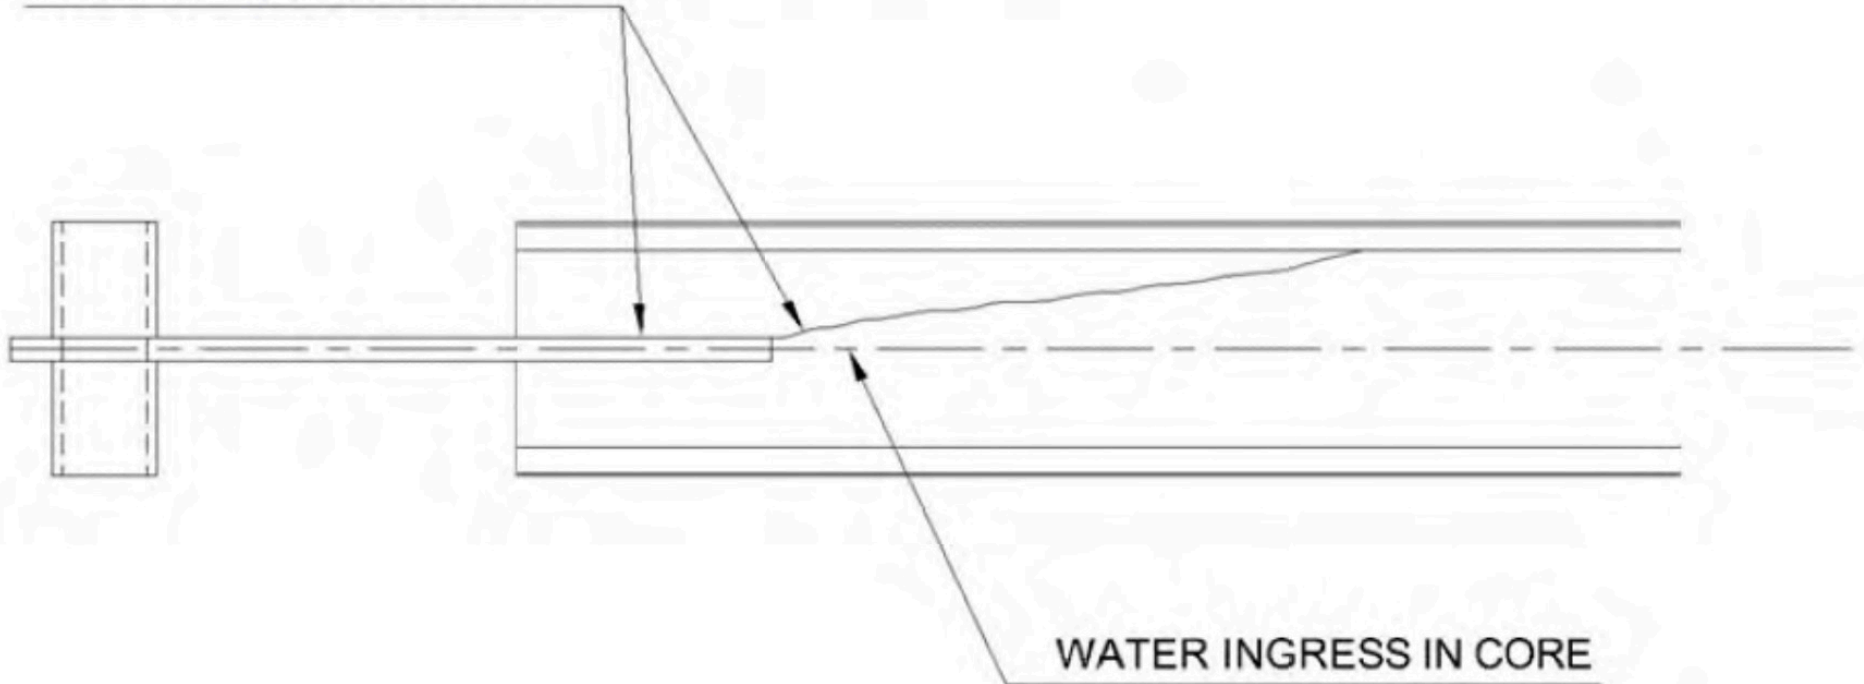
WATER INGRESS IN CORE

- Areas of friction between keel and keel case.
- Resulting wear over time had exposed wooden core, hidden from view.
- Extensive water damage of wooden core at modified locating pin locations, original pin locations and area “below the steel plate”
- Pin did not pass through both sides of keel; slumped down on port side.
- Failure of bond between locating pin steel structure and wood core
- Port skin separated from core and slumped.
- *“ Evidence suggests that the factors identified as causing the failure of the keel are associated with the modifications undertaken to raise the locking pins”.*
- *“ the design parameter for the mods were appropriate and did not cause the failure”*
- The keel mod drawings had no details on the bonding and sealing between the steel plate and the original keel.

“A combination of mistakes during the modification process, age wear, damage from minor groundings <either separately or in combination> are the likely causes of the slow deterioration of the upper portion of the keel”

- Modifications and repairs should be undertaken in accordance with best industry practice.
- Vessel owners should consider thorough inspection of keel (incl. inside keel case) if vessel grounded, and annually.
- When competing in an event the organisers must be informed of mods, repairs etc. so that they can determine if required safety standards are met.
- (plus three vessel operational safety recommendations)
