Centre for Marine Science and Technology

IMAGING OF A CRAYPOT MOORING USING MULTI-BEAM SONAR

Prepared for:
Fremantle Sailing Club

Report: CMST 2014 -38

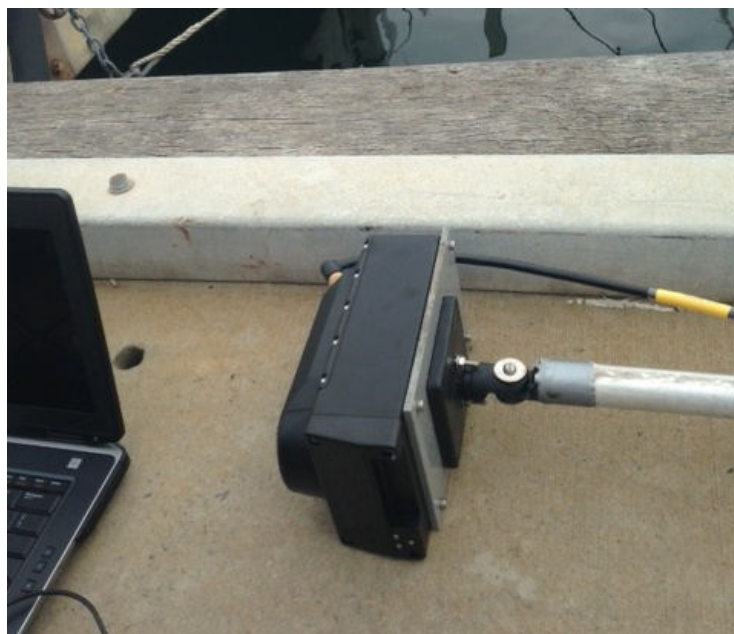
Figure 1: multi-beam transducer head

The trials were conducted using a Tritech Gemini 720i multi-beam sonar on loan to Curtin (Figure). It operates at 720kHz with a 120° horizontal field of view and 20° vertical beam-width. The effective angular resolution is 0.5° which corresponds to approximately 10cm resolution at 10m range.

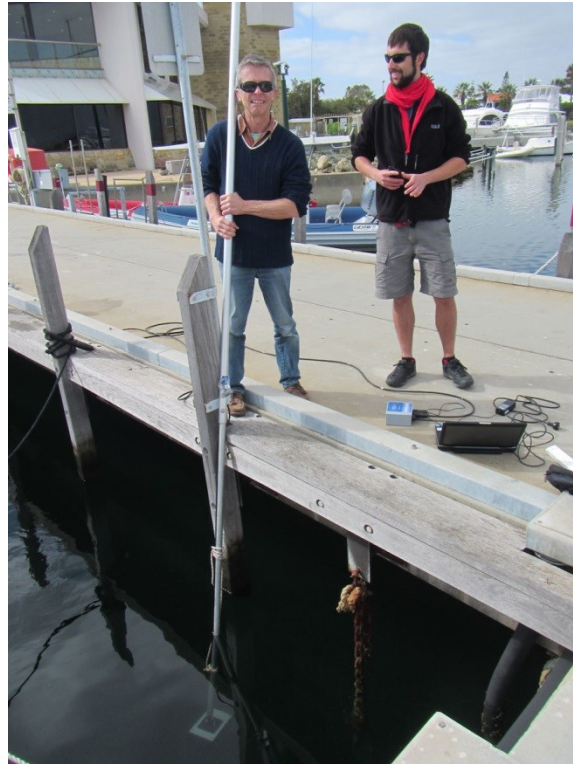
Figure 2: sonar deployed.

The sonar was deployed close to the junction of jetty “A” and the Collector Jetty. Power was from jetty mains supply. The sonar was mounted on the end of a 5m aluminium pole (Figure). For most of the measurements the sonar was held near or slightly above the horizontal plane, with 0° azimuth pointing approximately toward the target. The sensor head was approximately 0.5m below the water surface; water depth was approximately 3m.

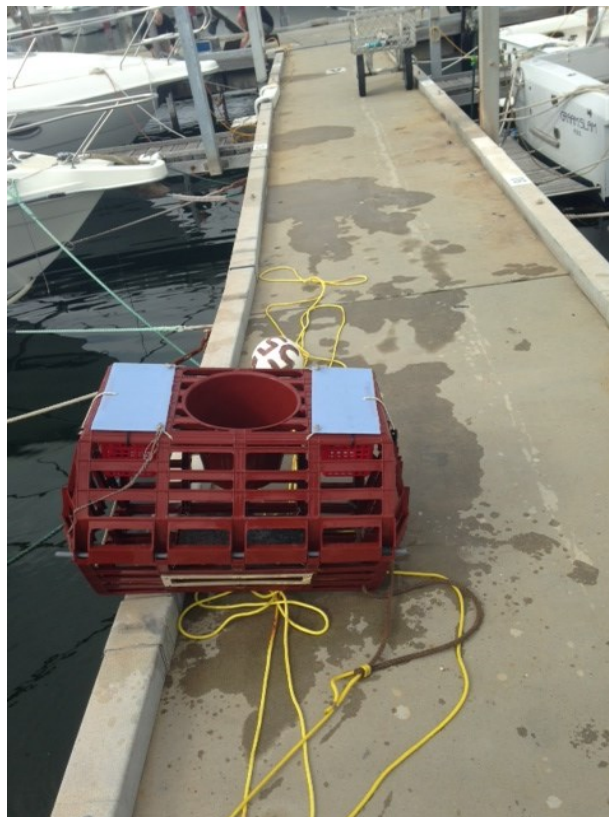
Figure 3: cray pot and float

The cray pot was typical of the ones used in WA – plastic, 700mm long, 600mm wide and 500mm high, of hexagonal cross section (Figure3). It was weighted down with a steel plate of approximately 10kg. A 10m length of 8mm diameter polyethylene line connected it to a 230mm diameter polystyrene float .

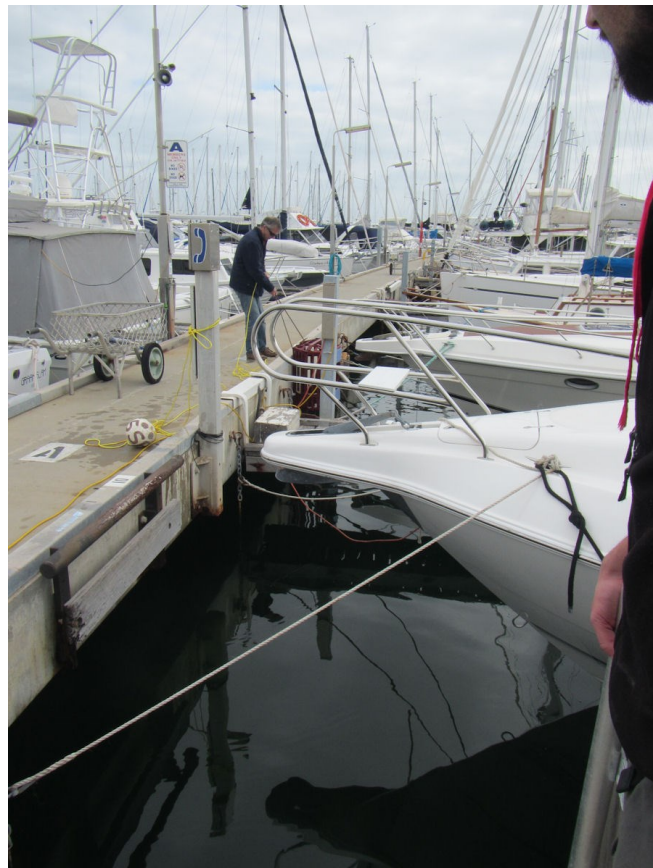
Figure 1: deploying craypot at 7m range

The cray pot was deployed on the seabed at various distances along jetty “A” (fig 4). There were several reflective objects in the water column nearby – a powerboat hull, concrete mooring weights and concrete jetty piles.

The cray pot and its float were deployed separately at ranges 4-15m from the sonar, approximately in line with its azimuth axis. For the float, recordings were made with the float both stationary and being bounced or jiggled on the water surface to simulate wave-induced motion.

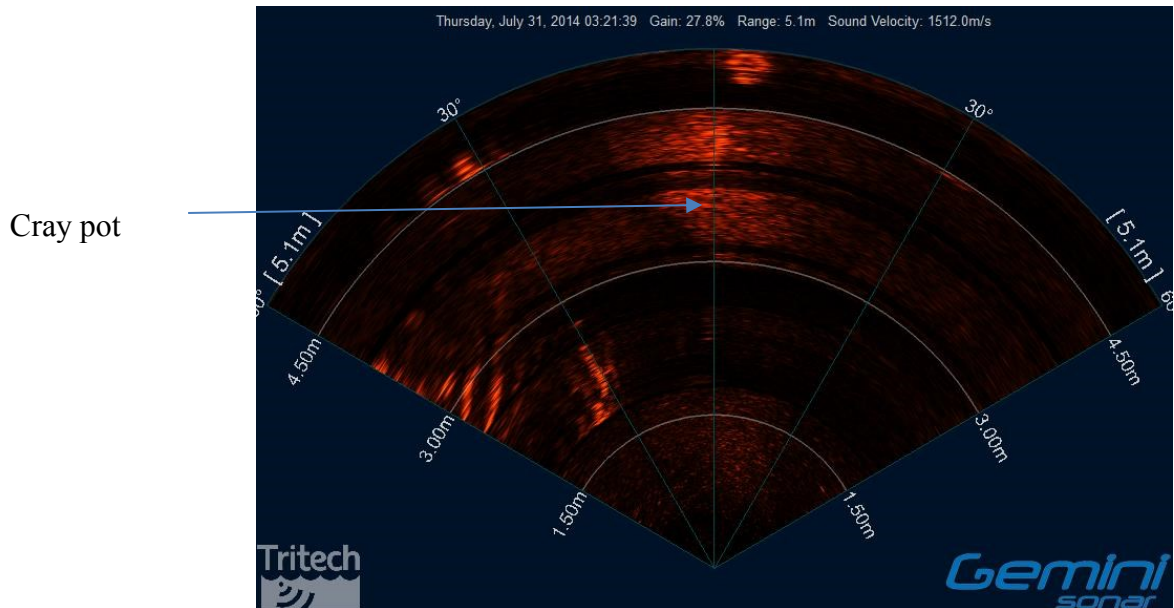
Figure 2: cray pot at 4m range

The cray pot could be detected at a range of 4m, but not identified as such (Figure 2). At 7m range it could be detected in real time but not during post-processing of the image i.e. you had to know it was there in order to see it on the screen. The pot was clearer in the image during deployment compared with on the seabed, possibly due to the large number of air bubbles seen rising to the surface as the pot sank in the water column. The cray pot line could not be detected at any time.

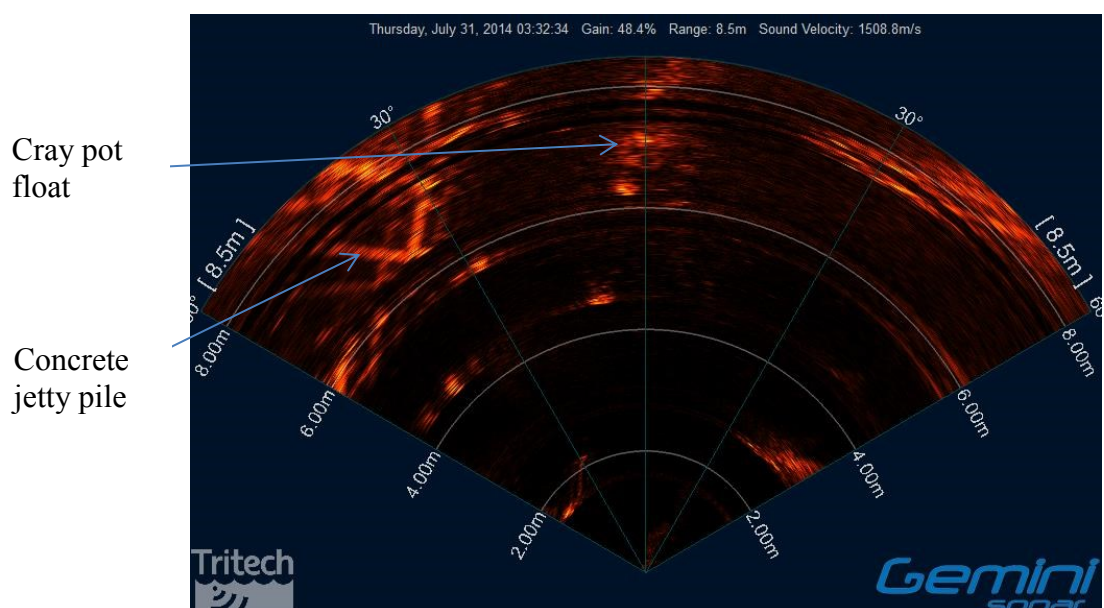
Figure 3: cray pot float at 7m range

The cray pot float could be detected in real time but not during post-processing of the image i.e. you had to know it was there in order to see it on the screen. This was the case for all ranges tested. However, if the float was bounced or jiggled on the surface, it could be detected at ranges of up to about 7m.

The stationary pot and the float could be detected at ranges of up to approximately 7m but could not be readily identified at any of the ranges tested. If the float was moving or the pot sinking, detection was improved, but the object could still not be identified for what it was.
