Yacht keel design and construction: what can we learn from the capsizing of *Finistere*?

Dr Kim Klaka

RINA WA 28th June 2022

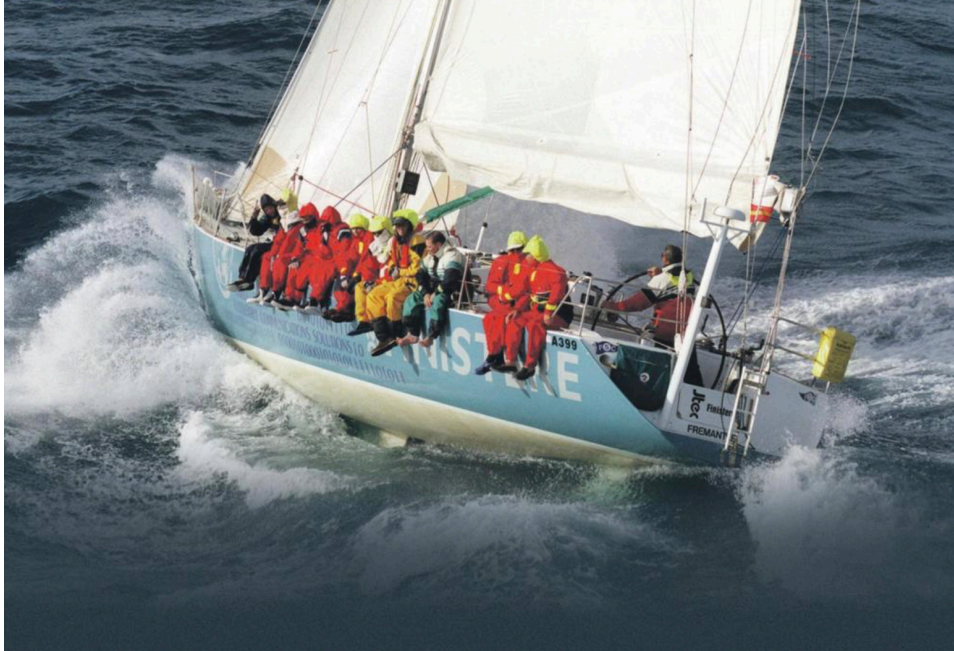
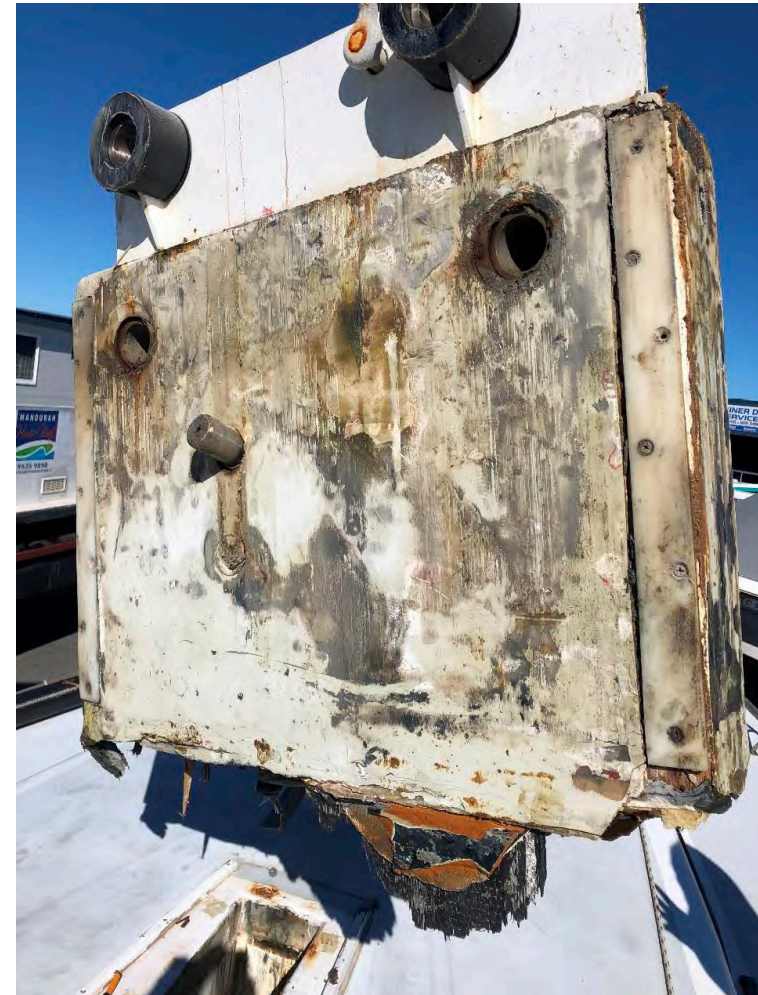
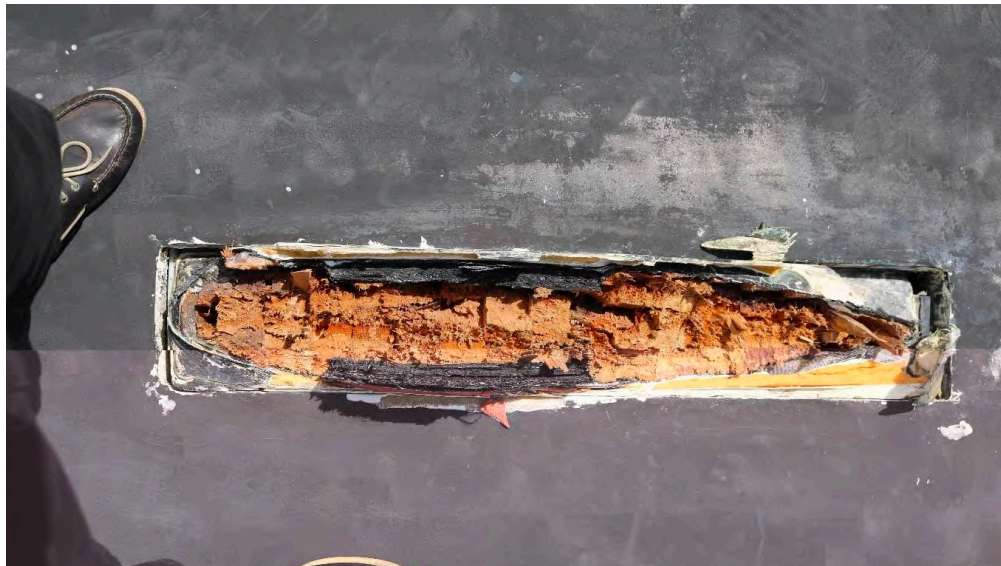
Finistere

- Davidson 50 built 1990 with fixed keel.
- Changed to lifting keel before 2002; composite oregon core, sheathed in carbon fibre.
- Keel delaminated in 2009, replacement keel installed “rebuilt as per the original drawings and specifications”.
- Locating pins that were at the height of the waterline, were modified and raised in 2012.
- Passed AS Cat 3 audit requirements Sept 2017.
- Vessel had grounded several times, including during the race prior to the capsized race.
- Capsized Feb 2018.

- Areas of friction between keel and keel case.
- Resulting wear over time had exposed wooden core, hidden from view.
- Extensive water damage of wooden core at modified locating pin locations, original pin locations and area “below the steel plate”
- Pin did not pass through both sides of keel; slumped down on port side.
- Failure of bond between locating pin steel structure and wood core
- Port skin separated from core and slumped.
- *“ Evidence suggests that the factors identified as causing the failure of the keel are associated with the modifications undertaken to raise the locking pins”.*
- *“ the design parameter for the mods were appropriate and did not cause the failure”*
- The keel mod drawings had no details on the bonding and sealing between the steel plate and the original keel.

“A combination of mistakes during the modification process, age wear, damage from minor groundings <either separately or in combination> are the likely causes of the slow deterioration of the upper portion of the keel”

- Modifications and repairs should be undertaken in accordance with best industry practice.
- Vessel owners should consider thorough inspection of keel (incl. inside keel case) if vessel grounded, and annually.
- When competing in an event the organisers must be informed of mods, repairs etc. so that they can determine if required safety standards are met.
- (plus three vessel operational safety recommendations)
