Fremantle Sailing Club

## ENTANGLEMENT OF BOATS WITH CRAYPOT GEAR

Boating WA

Report: Craypot solutions v1.02

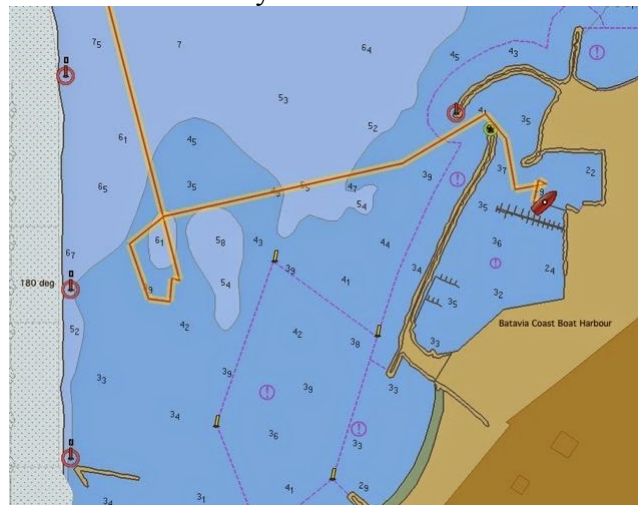
The fish beds lie where our track SSE abruptly halted

part of the mooring for an UNLIT fish farm and the mooring line from buoy to farm was between our keel and our rudder. Sticky situation.

Gradually we slid along the mooring line from the buoy end to the fish farm end. Fenders out and on the mobile phone to Geraldton Sea Rescue. They were superbly efficient. It was 2200 and their rescue boat was in the water within about 30 minutes and arrived about 15 minutes later. In that time I'd discovered all sorts of things about fish farms I never really wanted to know. Primary amongst the lessons was that this one was entirely plastic - there is a god! So the hull wasn't being "eaten" as we banged into the structure while stern-to in a 0.5m to 1.0m sea. Twasn't pleasant. I kept the engine going (in neutral) and revved it occasionally to ensure the waves weren't forcing water back up the exhaust into the engine. We took a couple of small greenies over the transom which wasn't fun.
